Uck Report

The River Ouse Project Report No. 6

University of Sussex, 2014

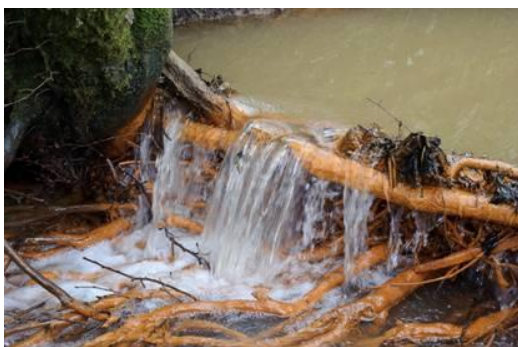
These dams can be constructed around an existing overhanging fallen tree by cutting so that one end drops into the watercourse and then dragging another log (1.5 times the channel width) into place to form a cross. Debris builds up on the upstream side. Since the debris may be washed out during storm events, these dams should not be constructed just upstream from culverts, which might block. However, in the upper reaches of the watercourse escaping debris is usually retained by a downstream debris dam (Thomas and Nisbet, 2008). Many of the gills we have surveyed have small, naturally occurring debris dams, which are already holding back the water and creating habitat diversity (Figure 2).

Figure 2. Natural debris dam in Limney Gill.

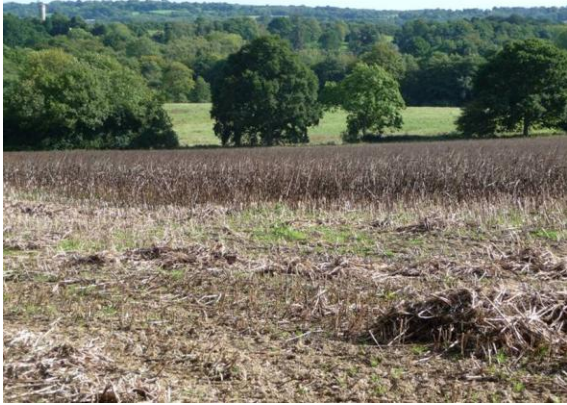
The public footpath was walked on 12 September 2010, but no detailed surveys have been done. The streamside is steep and wooded. The slopes above have arable fields with maize (Figure 3) and meadows with species-rich grassland such as meadows A and B in Figure 4 and Figure 5. Meadow C had cut hay drying in it at the time of our walk. In 1931 all these fields were meadow (Land Utilisation Survey).

Figure 3. Maize field with compacted soil above Brook Reach

Recommendations: convert arable land to permanent grassland thus removing adverse effects on Ecosystem Services (ES) and providing all the ES benefits listed.

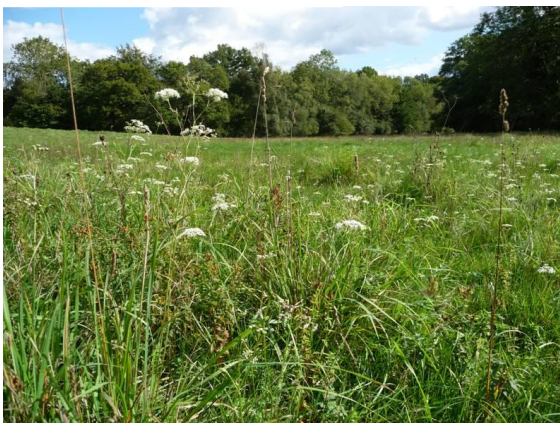
Figure 5. Species-rich grassland above Brook Reach.

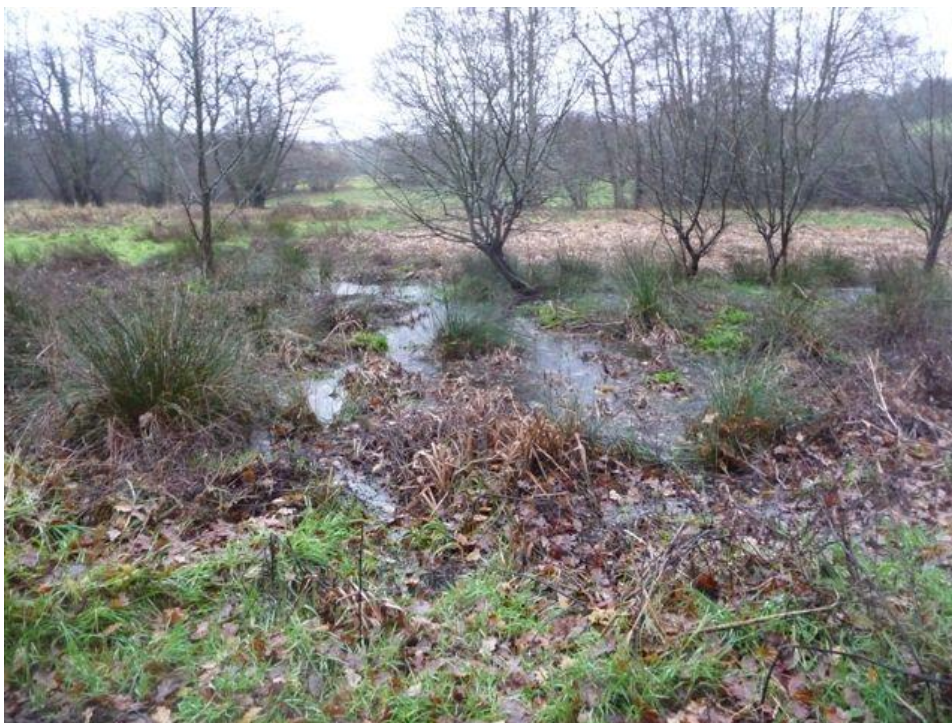
Figure 13. Shawford Farm Brook in January 2012, viewed from the road.

Recommendations: If the owners are agreeable, this low-lying wet site looks ideal for riparian woodland planting and, as it comes within a key CRIM reach, flood alleviation becomes paramount.

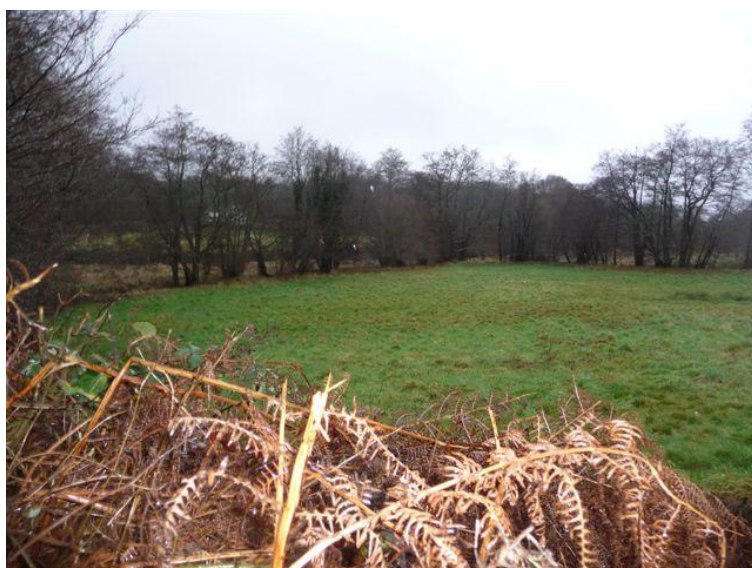
Brook Field (TQ521212, Figure 12) slopes up from the stream away from floodwaters and may be grazed by horses. It is MG1e (*Arrhenatherum elatius* grassland), but not a very species-rich example of this plant community with 16 (12–18) species per sample. Note: *Arrhenatherum elatius* is not eaten by horses. In 1840 (Framfield Tithing Survey) the field was being managed as pasture and in the early 1930s (Land Utilisation Survey) it was meadow. It is still predominately dry grassland, unlike Shawford Brook on the other side of the stream (Figure 14). However, the coarse *Arrhenatherum elatius* grassland is not as species rich as our target hay-meadow vegetation.

Figure 14. Brook Field in January 2012 with Shawford Brook in left-hand distance

Recommendations: This site is not such an attractive site as Shawford Brook for riparian woodland planting but a band of trees could be planted along the stream side, which would absorb rainwater and run-off from the slope above and so contribute to flood alleviation in this important CRIM reach.

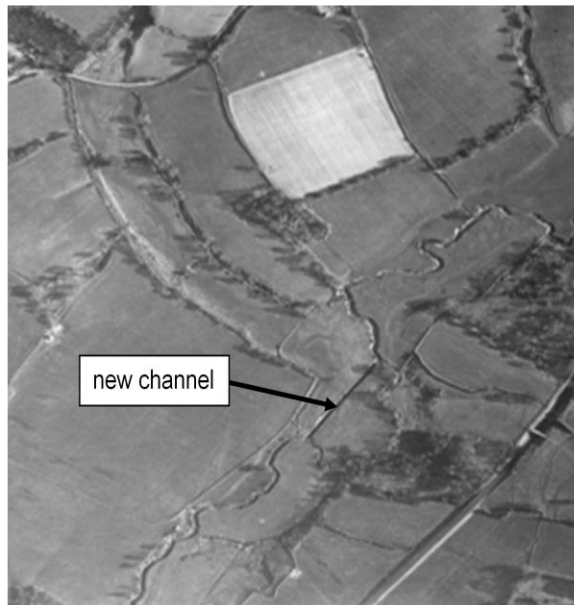
Figure 25. 1947 aerial photograph showing a straight section of the Uck (SAPC), Sussex air photo catalogue – 1940s. Photo no. 2034 FS CPE/UK1966. 10 April 1947. Global Studies Resource Centre, University of Sussex.

Recommendations: Reconnecting the meander to the river (provided this could be done with minimal disturbance) would make a major contribution to flood alleviation by slowing down the flow of water and increasing the amount of water flooding onto the land at peak flow (ES benefits 4, 5 and 6).
