Cockhaise Brook

The River Ouse Project Report No. 7 (updated 2020)

University of Sussex

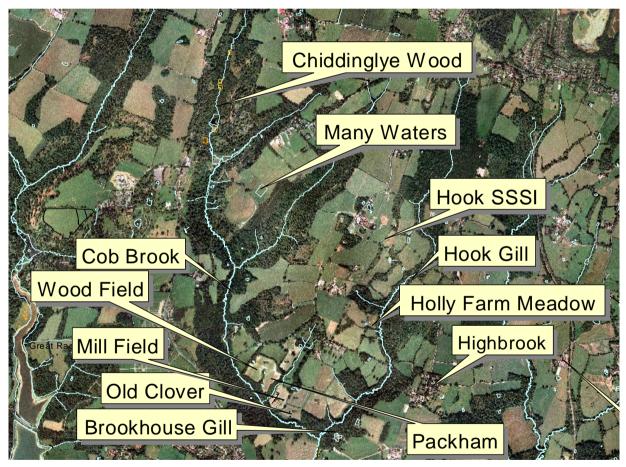
Figure 6 Sites on Cob Brook and Hook Ghyll.

Chiddinglye Wood (TQ346324, Figure 6) was surveyed in 2006 using the National Vegetation Classification method for woodland. This Alder-Ash-Yellow Pimpernel Woodland (W7a/c) was much more species-rich than the average with 42 (34–48) species per sample and, like the surrounding woodland which we have not surveyed, will be making a big contribution to preventing run-off (Ecosystem Service 1) and contributing to flood alleviation and reduction in sediment load (Ecosystem Services 7, 8 and 9).

Downstream from Many Waters Field, and also lying on a slope above Cob Brook, was an arable field growing maize in 2007 (Figure 6). Converting this field to permanent grassland would reduce run-off and sediment entering the Cockhaise Brook.

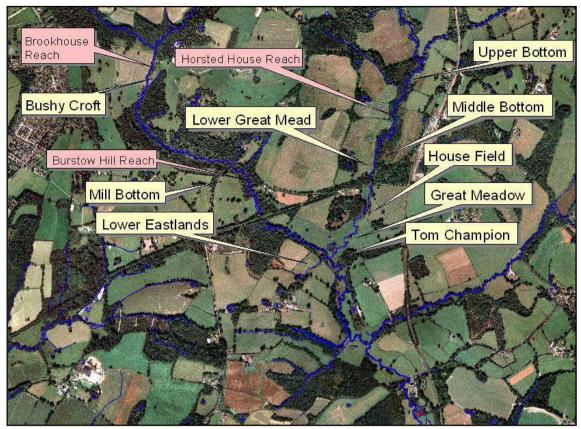
Figure 7 Brookhouse Reach, Burstow Hill Reach and Horsted House Reach.

Mill Bottom (TQ360287, Figure 7). This sheep-grazed rush pasture was surveyed on 9 July 2009. It is much more species-rich than the average for MG10b with 21 (14–33) species per sample and contained Common Spotted-orchid (*Dactylorhiza uchsia*) and Ragged-robin (*Lychnis flos-cuculi*). It is not a washland. In 1841 Mill Bottom was being managed as pasture (Tithe survey) and in 1931 it was a meadow (Land Utilisation Survey). Currently this meadow is providing Ecosystem Services 1-6.

Lower Eastlands Meadow (TQ364284, Figure 7) surveyed on 25 June 2014 was species-rich MG5c with 23 (16–31) species per sample. It was pasture in 1841 (Tithe survey) and had been grazed by Sussex Brown cattle over the winter prior to our survey (personal communication from owner).

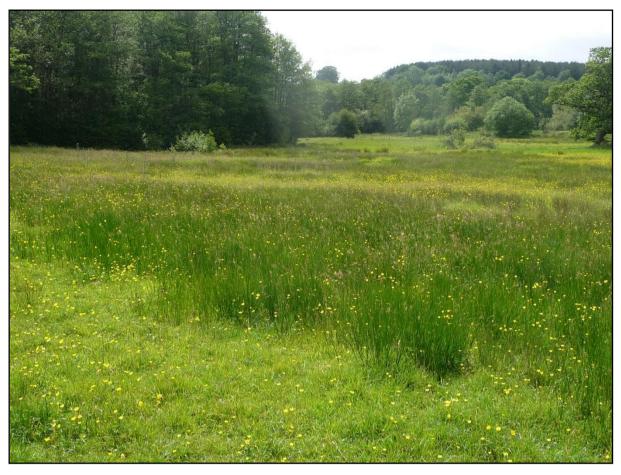
Figure 8 Rush vegetation in the southern part of Great Meadow, 17 June 2015.

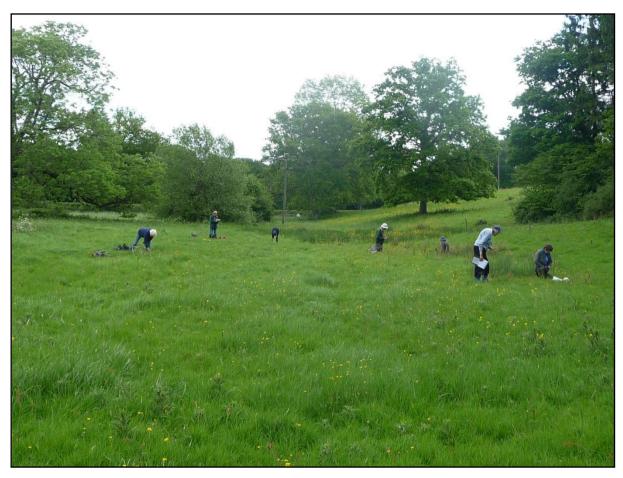
Figure 12 Kayesford Leg North looking towards Kayesford Leg South with Dencher Field on the slope above the area of rush.

Kayesford Leg North (TQ368277, Figure 9, p. 23). This species-rich MG6b meadow had 17 (15–18) species per sample when we surveyed on 3 June 2015. It leads into Kayesford Leg South through a narrow waist and is continuous with Dencher Field on the slope above (Figure 12). There is a small, spring-fed area of rushes at the base of the slope. It was managed as pasture in 1841 (Tithe survey) and as meadow in 1931 (Land Utilisation Survey). In recent years it has been managed as cattle-grazed pasture.

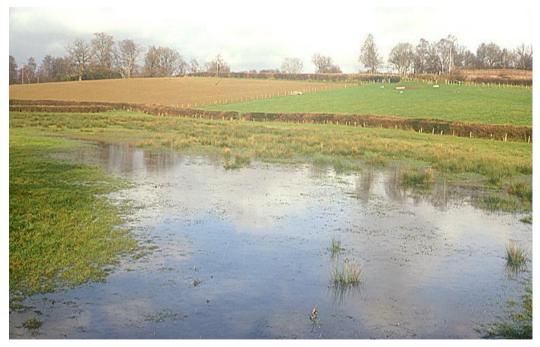
Figure 13 Caseford Bottom washland in flooded state.

Caseford Bottom (TQ370277, Figure 9, p. 23). This MG10a pasture is a washland and was much more species-rich than average with 20 (16–30) species per sample when we surveyed on 13 June 2007. Sneezewort (*Achillea ptarmica*) and Ragged-robin (*Lychnis flos-cuculi*) were present. It was meadow in 1841 (Tithe survey) and in 1931 (Land Utilisation Survey). It has never been ploughed and recently has been grazed by cattle between May and October each year at a low level of intensity: about 30-40 young cattle are put in until they have eaten the grass off and are then taken out (Nick Geering, oral history interview 21 August 2007 by Andrew Holmes). It is providing Ecosystem Services 1, 2, 3, 5, 6, 7, 8 and 9 (Figure 13).

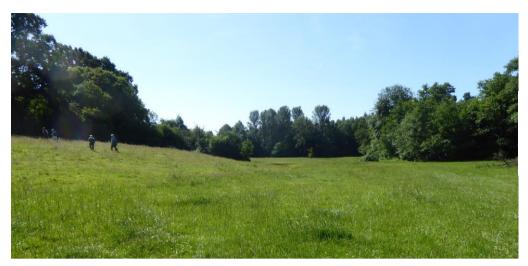
Figure 15 Long Lag with the slope surveyed to the left.

Long Lag is currently grazed by a large herd of cattle which graze intensely and are then moved on. The area selected to survey was the 10 degree slope rising to the east (Figure 15) which was selected because it had noticeably less Ryegrass and more wildflower species. Perhaps the cattle spend less time grazing the slope and prefer the flat area at the bottom. It is providing Ecosystem services 1, 2, 3, 5, and 6. Several Meadow Brown butterflies were seen. Long Lag was meadow in 1839 (Tithe Survey) and in 1931 (Land Utilisation Survey).
